Re: Supplemental Response
Southeast Rockford Groundwater
Superfund Site (the "Site")

This letter is written in response to the questions which you raised during our November 29, 1990 meeting with respect to Sundstrand's CERCLA 104(e) Response dated July 24, 1990 to the EPA's Supplemental Request for Information dated June 20, 1990. The following points are numbered in accordance with the EPA Supplemental Request for Information dated June 20, 1990. Each item consists of Sundstrand's explanation and additional facts, if any.

Question No. 5 - you asked whether additional spills took place at the 4747 Harrison Avenue, Plant 6 location. Attachments 3 through 5 provided the responses for Question No. 5. They contain information describing applicable reportable quantity spills as defined by CERCLA and any spills reportable under other federal statutes, for example, the underground storage tank regulations.

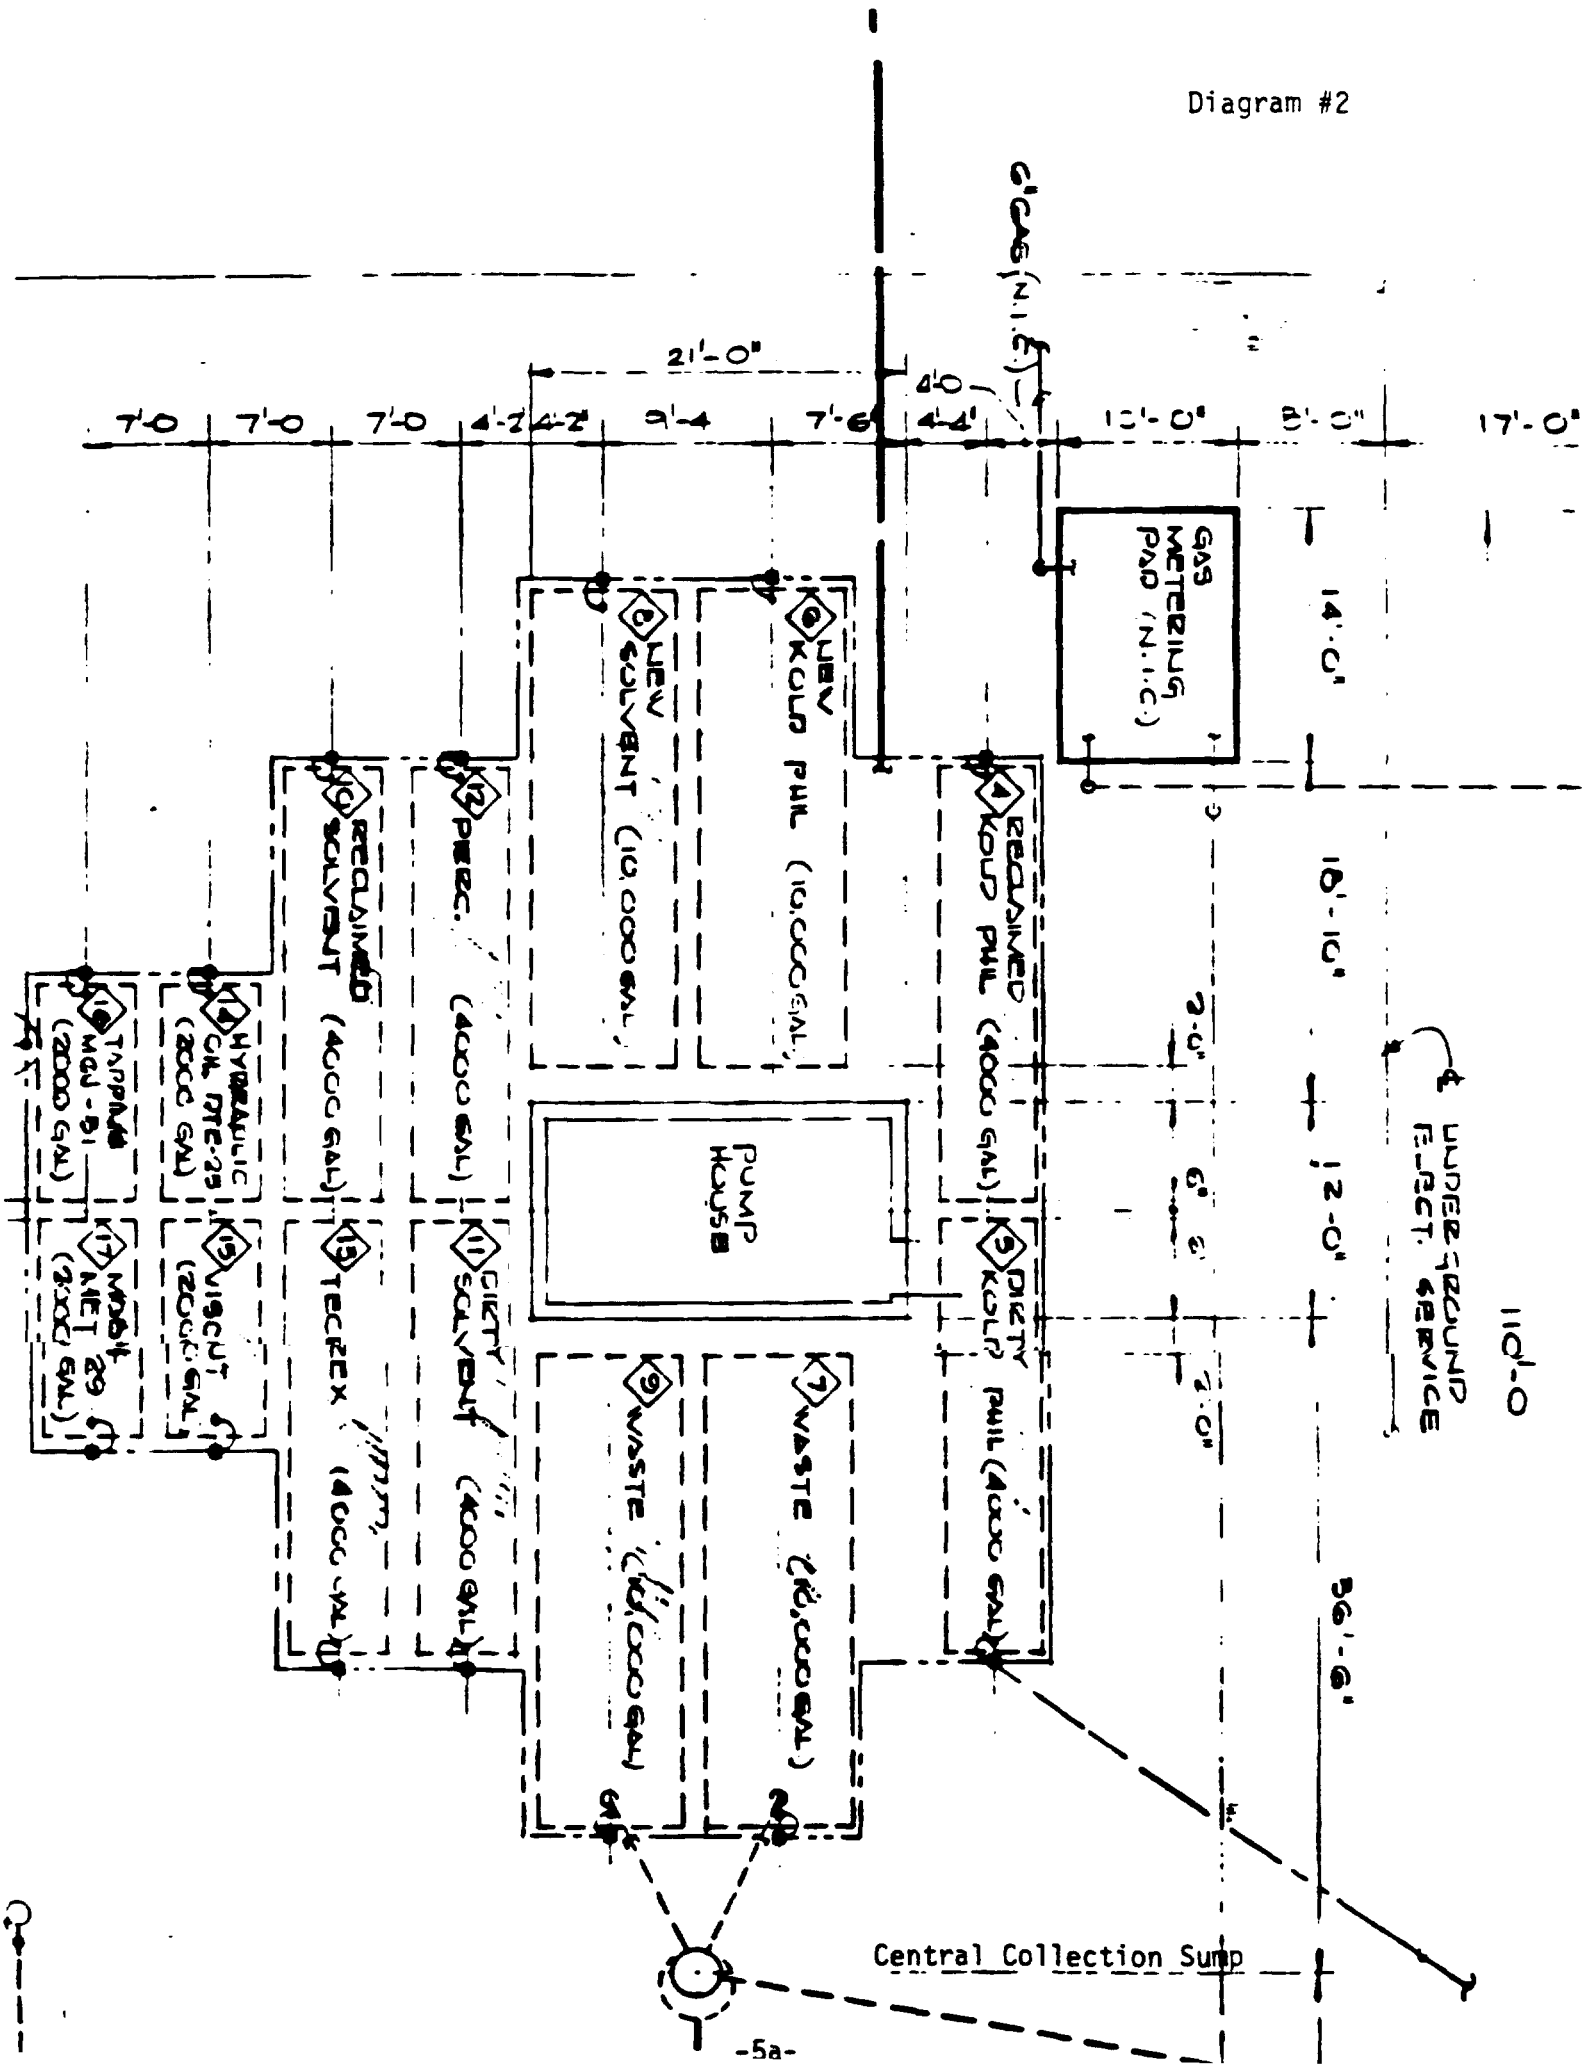
Diagram #2

While only two (2) of the existing fourteen (14) underground tanks are strongly suspected of leaking, we have addressed the entire tank farm in this proposal. It is felt we should address the entire area to eliminate potential exposure than apply a band aid type of solution.

- 5) Remove four (4) 2,000 gallon tanks (#14, 15, 16 & 17), back fill and resurface. \$15,000.
- 6) Remove four (4) 10,000 gallon tanks (#6, 7, 8 & 9), back fill and resurface. 28,000.
- 7) Remove and install new tank #8. 5,000.
- 8) Tanks #4, 5, 10 and 11 will be eliminated. Combine tanks #12 and 13 (4k each) into one 8,000 gallon compartmentized tank. Combine tanks #14, 15, 16 & 17 (2k each) into one 8,000 gallon compartmentized tank. Combine tanks #7 & 8 (10k each) into one 15,000 gallon tank. Tank #6 will be relocated above ground. Tank #8 will be replaced with an underground double wall tank with leak detection system between walls.
- 9) Above ground tanks will consist of two (2) 8,000 gal., (1) 10,000 gallons and one (1) 15,000 gallons.

(2)	8,000 gallons - 8'-0" x 22'-0"	12,000.
(1)	10,000 gallons - 9'-0" x 21'-0"	7,500.
(1)	15,000 gallons - 10'-6" x 24'-0"	11,500.
- 10) The below ground tank (#8) which is of double wall construction is 10,000 gallons. 12,000.
- 11) A concrete containment area to be 56' x 30' x 3' in dimension. 12,000.
- B. Piping from new tanks to pump house. 3,500.
- C. 1) Remove existing central collection sump and replace with two (2) new ones constructed to prevent leaks. (Diagram 2c) 3,500.
- 2) Sample soil around sump for contamination and disposal of approximately 50 cubic yards in licensed landfill. 3,800.
- D. 1) Remove one (1) 500 gallon diesel fuel tank. 1,500.
- 2) Back fill and install containment area and resurface. Install one (1) new above ground 500 gallon diesel fuel storage tank. 2,000.

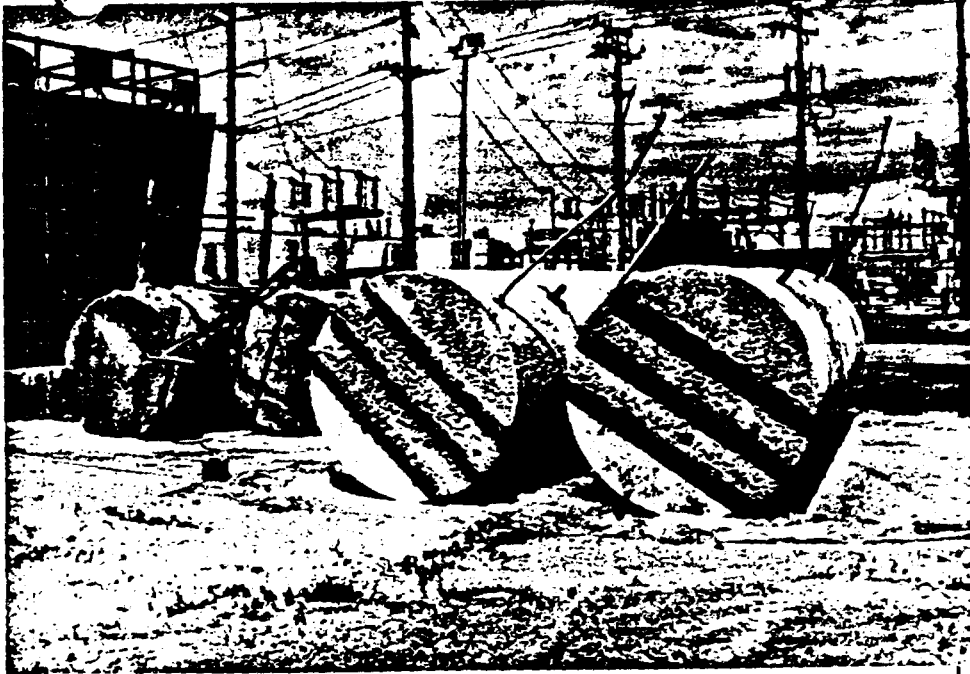
PLANT 8 U.S.T. REMOVAL

CONTAINMENT, BERMING & COVERING
FOR SOIL REMOVED FROM TANK #34 & 3
EXCAVATION SITE.8. ☐ Confidential Materials

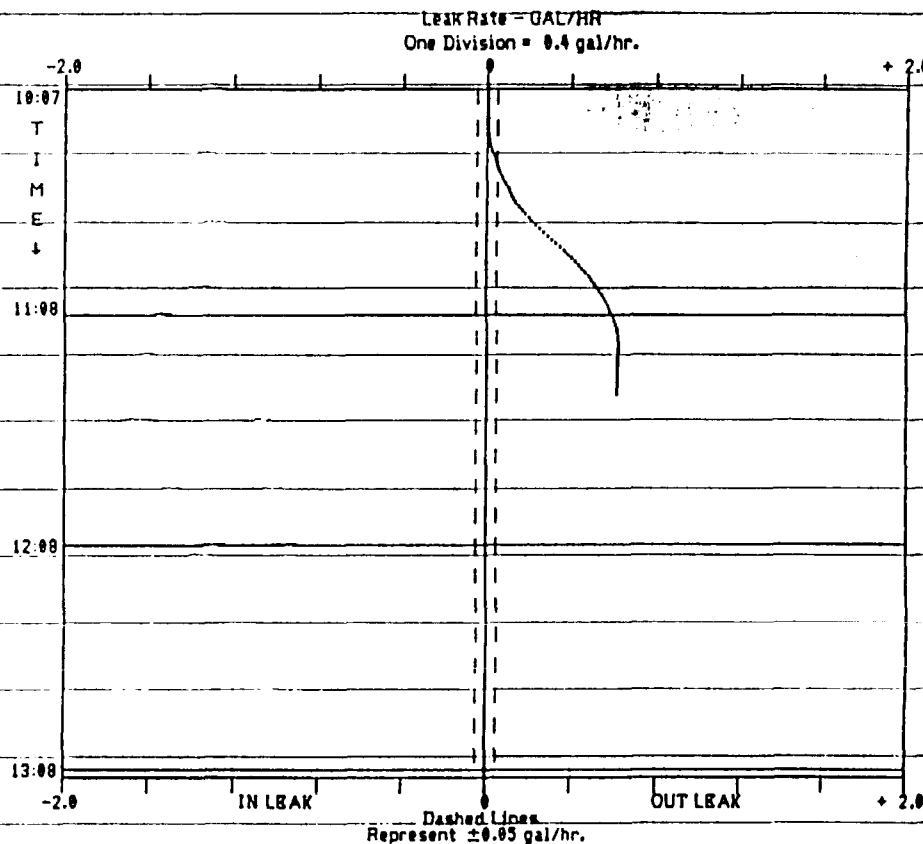
STRIP CHART FOR DATA RECORD: 89042190.A72 OF 10000 GALLON WASTE/WATE TANK

Final Average Leak Rate: 0.6160 gal/hr.
 Rate of Temperature changes: 0.0045 °F/hr.
 Rate of Volume changes: -0.6026 gal/hr.
 0.99 Error Bands ± 0.08 gal/hr.
 Tank and System: FAIL at 60 Inches ABOVE Tank Top.
